Lucas 18D2 Distributor Ignition Timing Corrections By Paul Allen

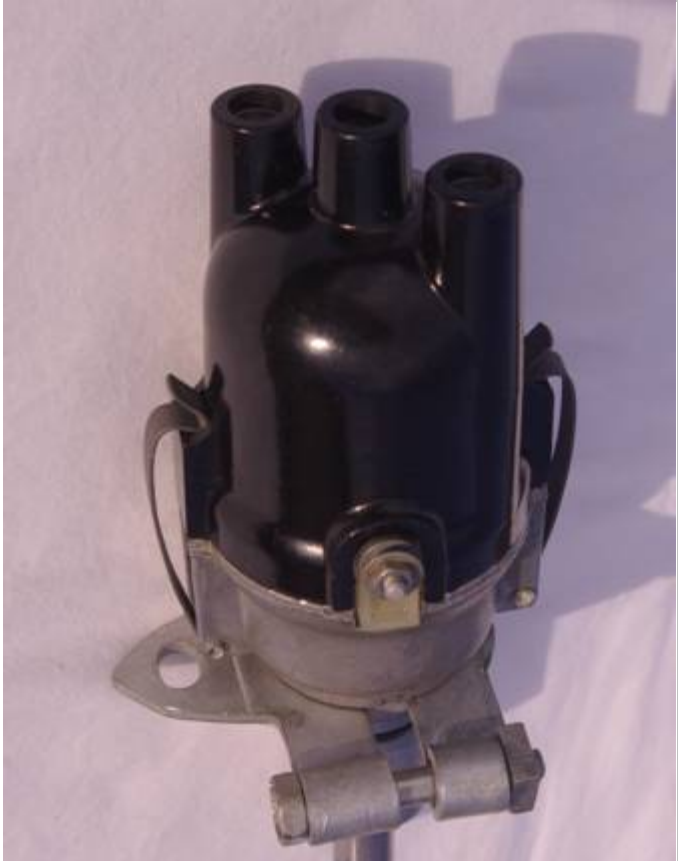
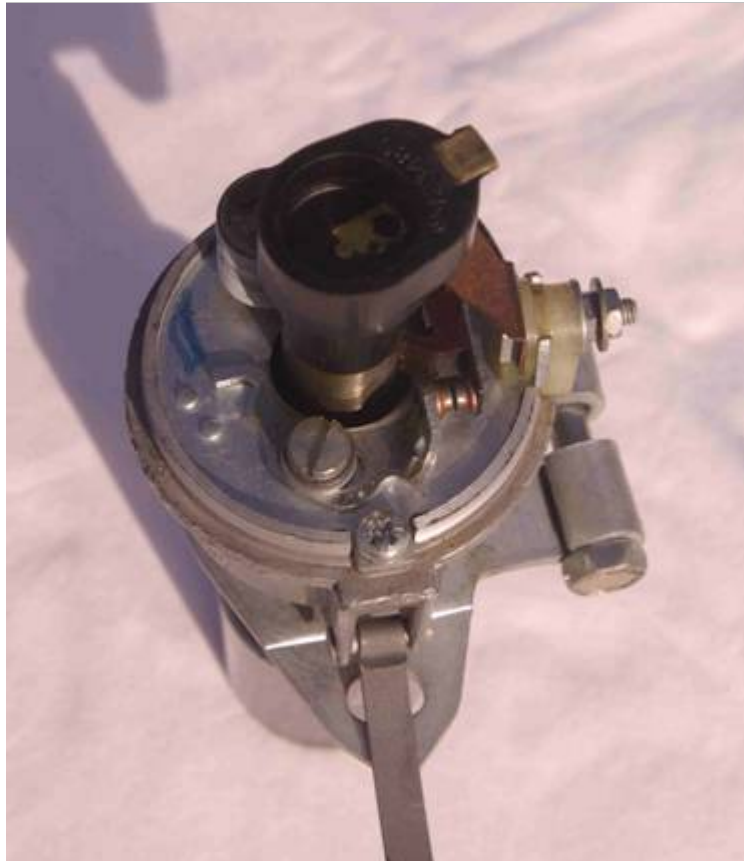
It took a bit of tweaking on the lathe- no metal removal, just bending- to make the shaft concentric along its full length. It turns out the steel shaft had a "memory"- straightening it in one direction always required perhaps 10x more force than in the reverse direction. Until I learned this, with very little effort I would overcorrect and return the shaft to its full, original "bent" condition. Finally, after lots of trials, it was true. I lubricated and reassembled the newly straightened shaft, its advance mechanism and the points plate in the distributor body. But then I found to my dismay that the point gap on one lobe was still very different than on the other- 0.024" vs 0.014".

I then mounted a timing degree wheel to the bottom of the distributor drive gear with duct tape, and fashioned a wire indicator pointer. I used a continuity tester across the points to see what that points gap difference might represent in terms of an ignition timing difference. By my test methods, the 0.010" difference in point gap equals 7.5 degrees in crankshaft timing difference- not good.

Throwing away all my earlier work truing the distributor shaft in the lathe, I decided to just go for the desired end result. By inserting a narrow-blade screwdriver between the highest lobe of the points cam and the center hole in points base plate in the distributor, I tweaked the shaft until the points gap became equal on each lobe. With my timing disk and continuity tester, I checked ignition timing differences along the way, as I made improvements in gap. In a short time I had leveraged the shaft until I had 0.018" gap at the top of each lobe. (Note: That's not a clearance I will use in running the engine.) Voila!- the previous measured ignition timing difference on each cylinder also disappeared. I love it when the planets align and the world finally makes sense, even if only for a brief moment!

So with an 18D2 distributor in reasonably good condition, getting the plugs to fire with the same timing on each cylinder should be simply a matter of tweaking the distributor shaft as needed to get point gap identical on each cam lobe. With care and finesse, this can probably be done with the distributor mounted in place on the bike. My concern about a possible imperfect grind on the Lucas breaker cam has now been put to rest. On with the remainder of the rebuild, one step at a time!
