Saga of a late Matchless twin air filter By Paul Allen

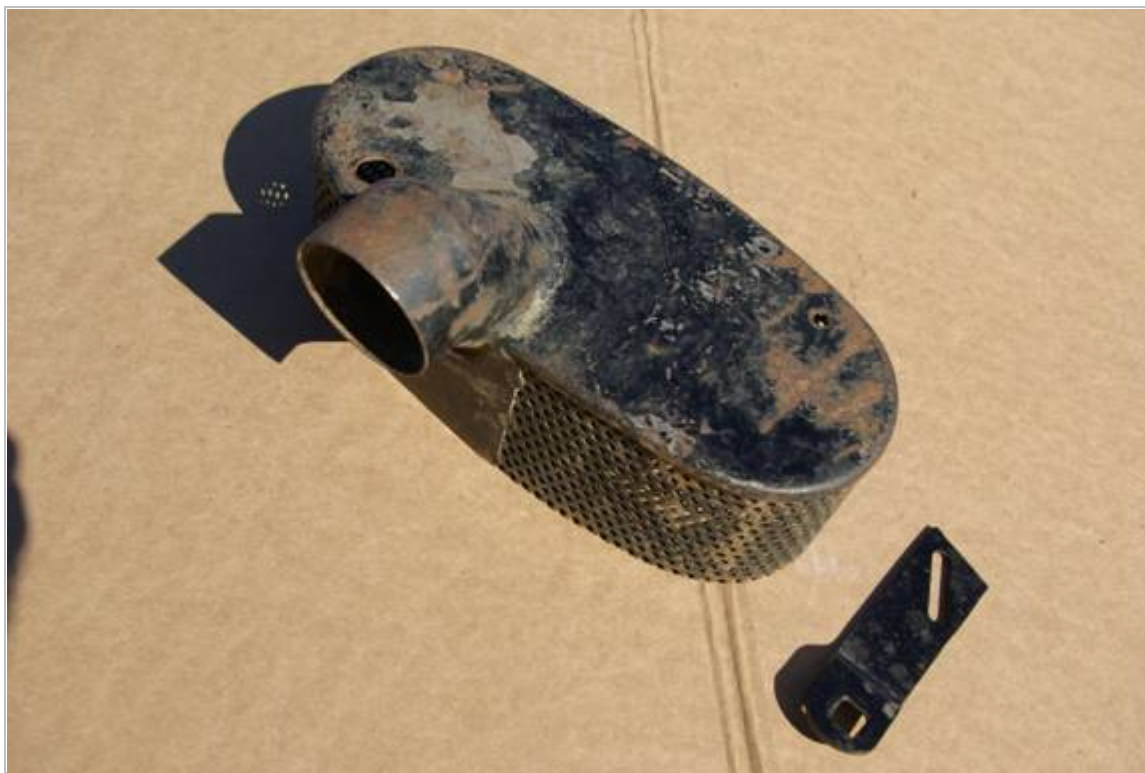
When the air cleaner case and bracket arrived, seemingly complete, I was quite puzzled by the layout of the parts. Over the next several days, realizations slowly began to gel. They have to come at their own pace, and I try to be patient. The first discovery, shown in photo 1, was a rusty witness mark towards the bottom of the inside cover of the used air cleaner case. This perfectly matched the shape of the NOS mount bracket. Evidently, the air cleaner I had bought was actually part number 026337, intended for the 1963 G12 CSR!

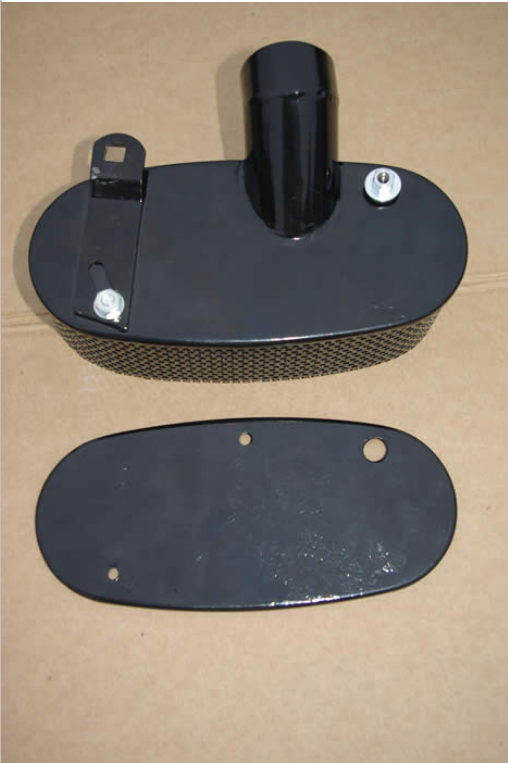
But how were the inside and outside covers of the air cleaner case held together? The outer cover had some strange holes in it, including another half inch one. But when it was assembled, none of those outer plate holes matched any hole locations on the inside cover for a through bolt or two. It finally dawned on me that except for the very large 1 3/4" air inlet tube hole, the holes in the inside and outside cover were identical, if you think of them both as inside covers. This can be seen in photo

2, taken after the parts were powder-coated. The fact that there were holes in what served as the outer cover merely meant that it had gone through some of the same preliminary manufacturing steps as the inner cover, and could easily have been further finished as an inner cover. When that side plate gets used as an outer cover however, the holes are merely incidental. Still, the question remained- what keeps the covers together?

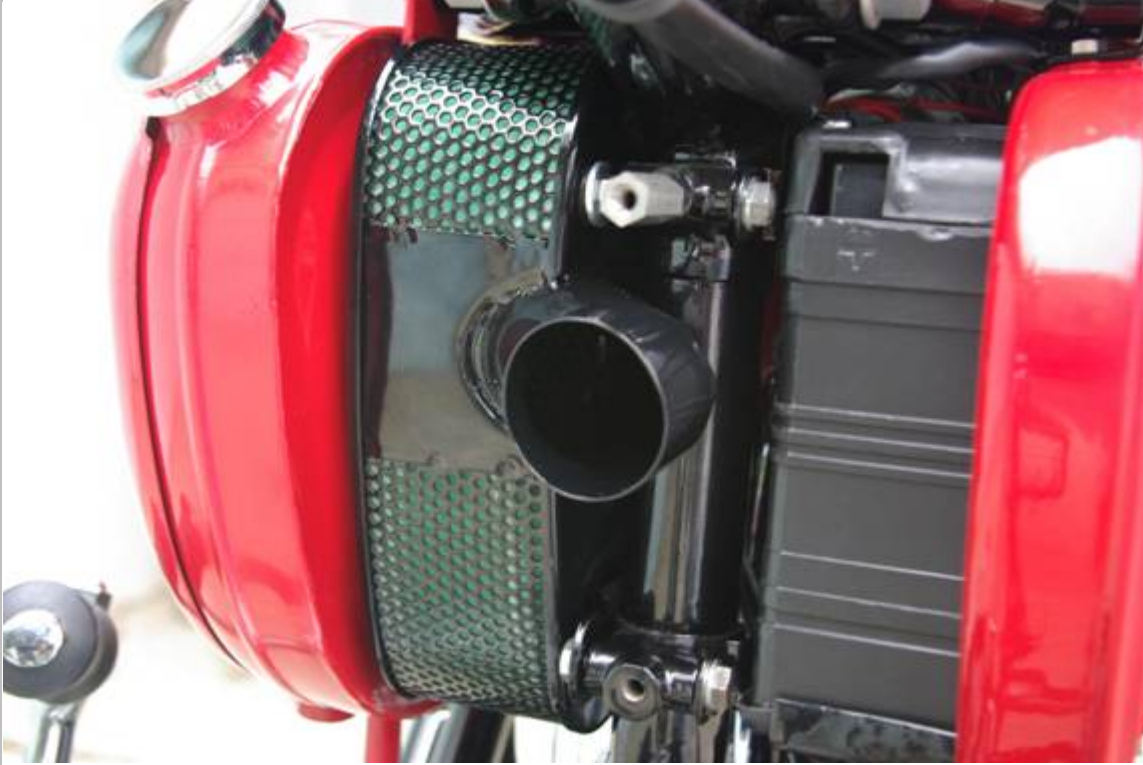
Fitting the freshly powder coated air cleaner on the bike again, I noticed that the case is a very tight squeeze between the frame downtube and the inside of the oil tank, as shown in photo 3.

So tight in fact, that to get the air cleaner in place, you actually have to loosen the oil tank quite a bit to install the cleaner. With the cleaner installed and the oil tank tightened back in place, there is no way the outer cover of the air cleaner will come off the screen cage of the airbox! So no through bolts on the air cleaner case were used or needed at all! In fact, when I get the engine installed in the frame, I may find I have to remove the oil tank to service the air cleaner. I guess that's better than having to remove the engine to get to the filter, though. Perhaps that's why they used this model filter for only one year on the G12 CSR's.

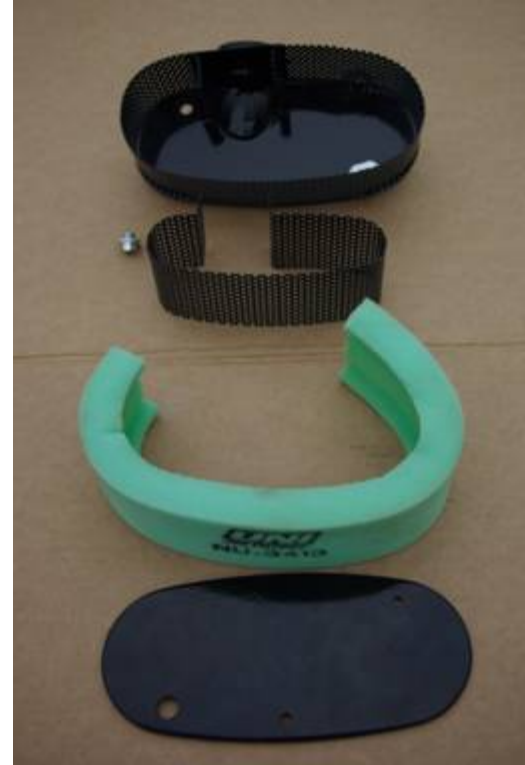
I cut a length of suitable air filter foam to use in place of the original mesh fabric, oiled it properly, and completed final assembly of the filter. All of the unassembled pieces are shown in photo 4. With the upper and lower frame covers in place between the oil tank and toolbox, as shown in photo 5, you have little idea that there is a very effective, large capacity air cleaner inside. But it's reassuring that my precious rebuilt engine will be breathing clean air.
