The Late G80CS, Norton Oil Pumps and Wet Sumping (Caveat Emptor)

By Paul Allen

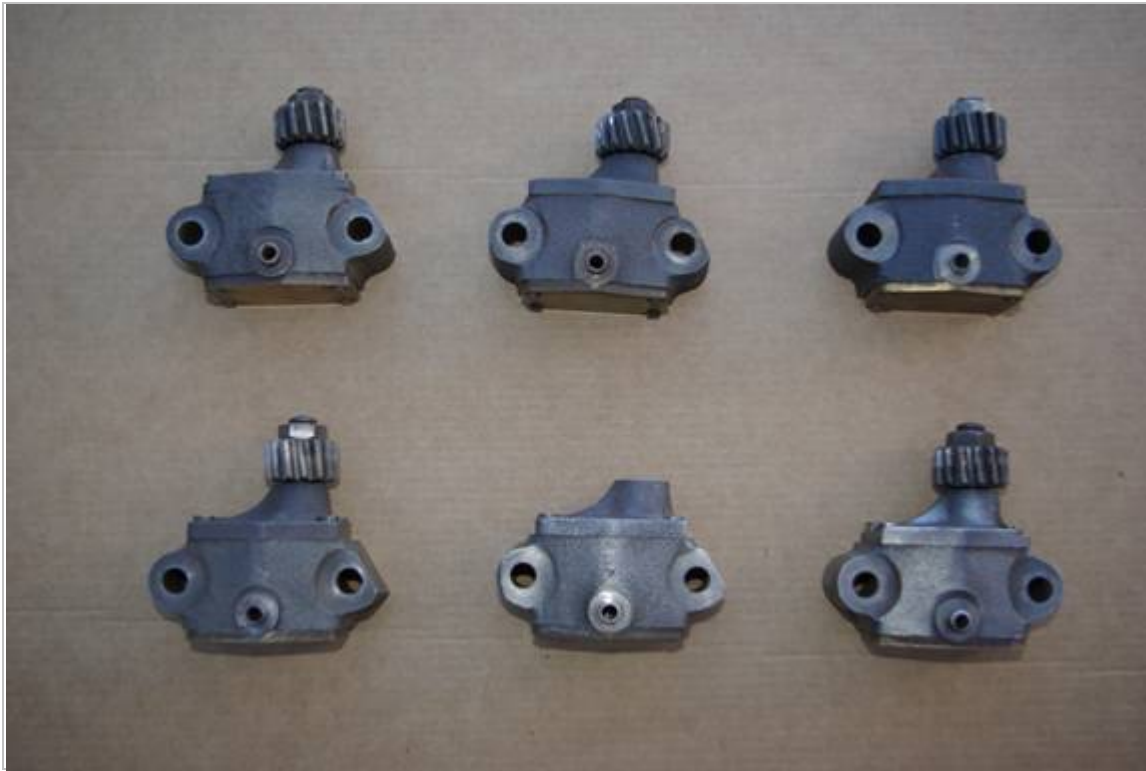
I have collected a small set of Norton-style oil pumps, ranging from NOS to well used ([photo 1](#)). Two of these are genuine G80CS pumps, two complete pumps and one partial are for Commandos, and one is an earlier Atlas pump. On eBay, each was described as a "G80CS Norton-style" pump, hence the "caveat emptor" above.

A 650cc Atlas oil pump, shown in the lower right corner of [photo 1](#), has the same 3/16" feed gears as a G80CS pump. It is almost identical, but lacks a clearance bevel on one end of the pump body. The clearance bevel isn't actually needed for fit on a G80CS, so an early Atlas pump can be used without modification. In engines with Norton oil pumps, wet sumping when the engine is off can result from leakage past the feed gears, into the engine oil feed galleries and ultimately down into the crankcase. As shown in [photo 3](#), a 1964 or later G80CS timing chest contains a ball check valve, with light spring pressure, which tries to shut off this gravity feed flow path when the engine is off. To assure the check valve works well, it should be carefully pried out of the timing chest, and the ball should be re-seated with a brass hammer or drift before reassembling the timing chest and installing it on the crankcases.

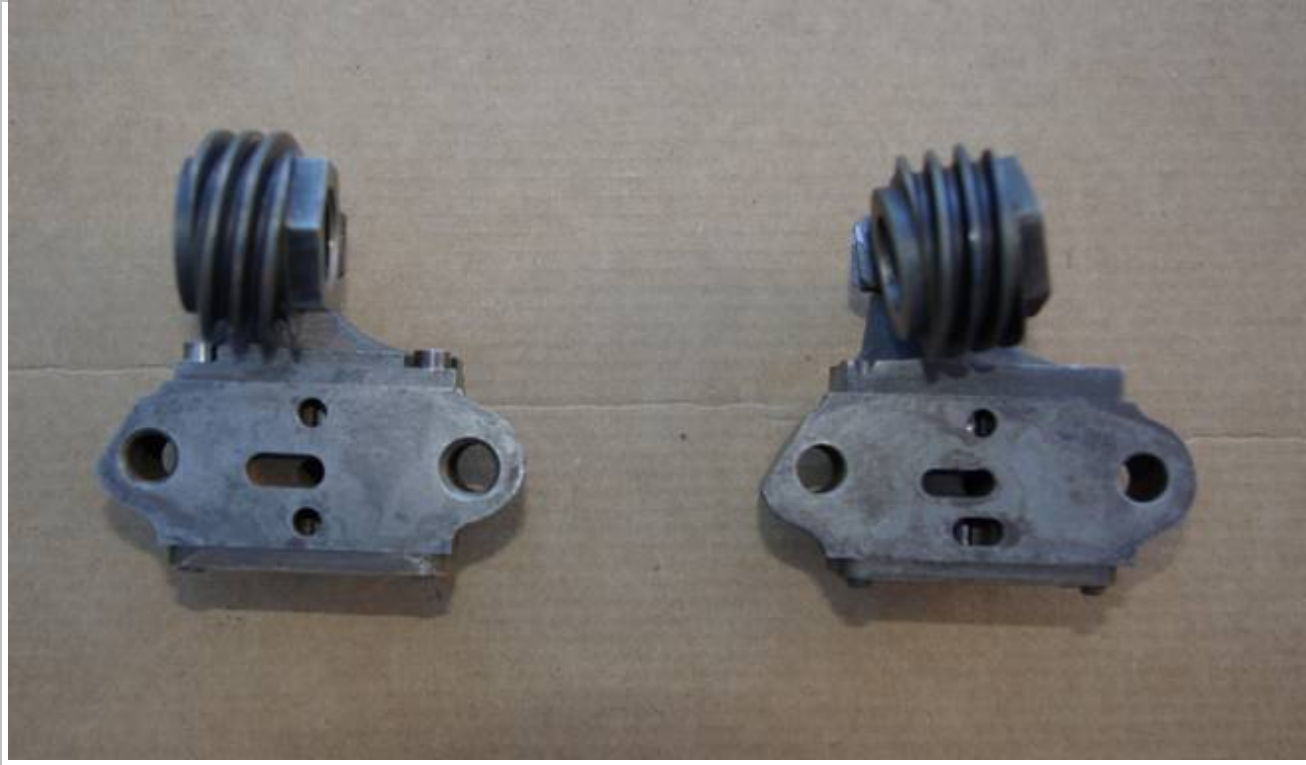
In later years, Commando pump output was increased even more by changing the tooth angle of the worm drive, and thus increasing the pump rpm. Early and late drive worms and gears cannot be mixed without disastrous results. [Photo 2](#) shows an early and a late Commando pump, with G80CS drive worms in place for reference. The correct crankshaft drive worm axis should be 90 degrees to the pump shaft axis, as on the left. If your fit is oblique, as on the right, you must either find another pump or install an earlier drive gear.

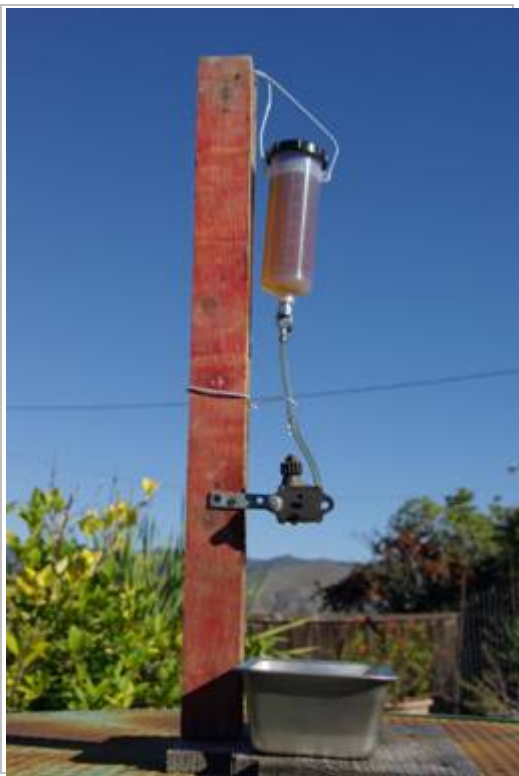
answer, I cobbled together a crude test rack which includes an oil delivery reservoir graduated in cc's, mounted to provide a 15" standing head of oil above a test pump. A drip pan underneath collects anything that leaks from the pump ([photo 4](#)).

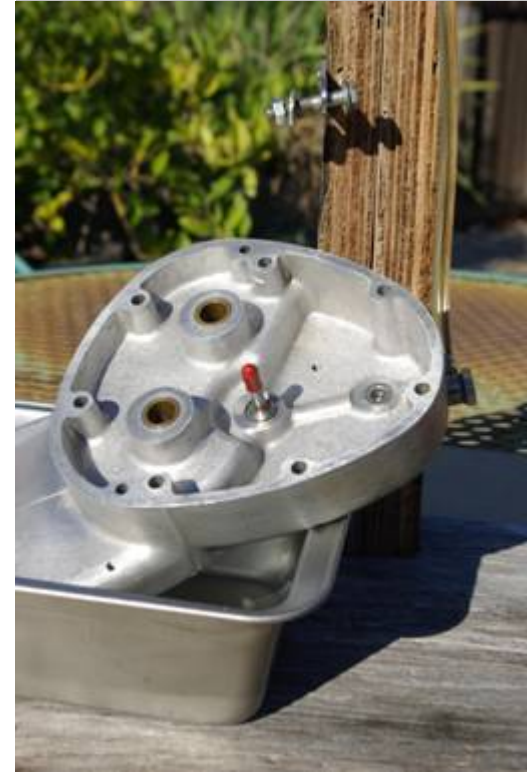
For a second series of tests on the pumps, I carefully dressed the base of each pump body and its mating bottom plate, using 400 grit wet-or-dry sandpaper on a flat plate, for a tighter fit. Because it was new, I opted not to dress the bottom of the NOS Commando pump or retest it, although its leakage might also be reduced by dressing. In the second set of tests, each pump leaked significantly less. Especially after dressing the pump bases, the amounts of pump leakage seem very minimal. Then I used my test rig to measure how much oil leaks through the ball check valve in the inner timing cover, at rest. On two inner timing covers, I hooked my plastic oil feed line to the bottom banjo fitting which normally provides oil feed to the rocker box, and capped off flow that would go through the crankshaft feed quill, as shown in [photo 6](#). During the 24-hour test, I pushed the ball off its seat several times, to try different ball/seat variations.
